| Site 33 | Motuotau (Rabbit) Island | Risk ranking: 1 |

| Site 34 | Waikareao Estuary | Risk ranking: 1 |

| Site 35 | Waimapu –Yatton Park | Risk ranking: 3 |

| Site 36 | Waimapu – Windermere | | Risk ranking: 3 |

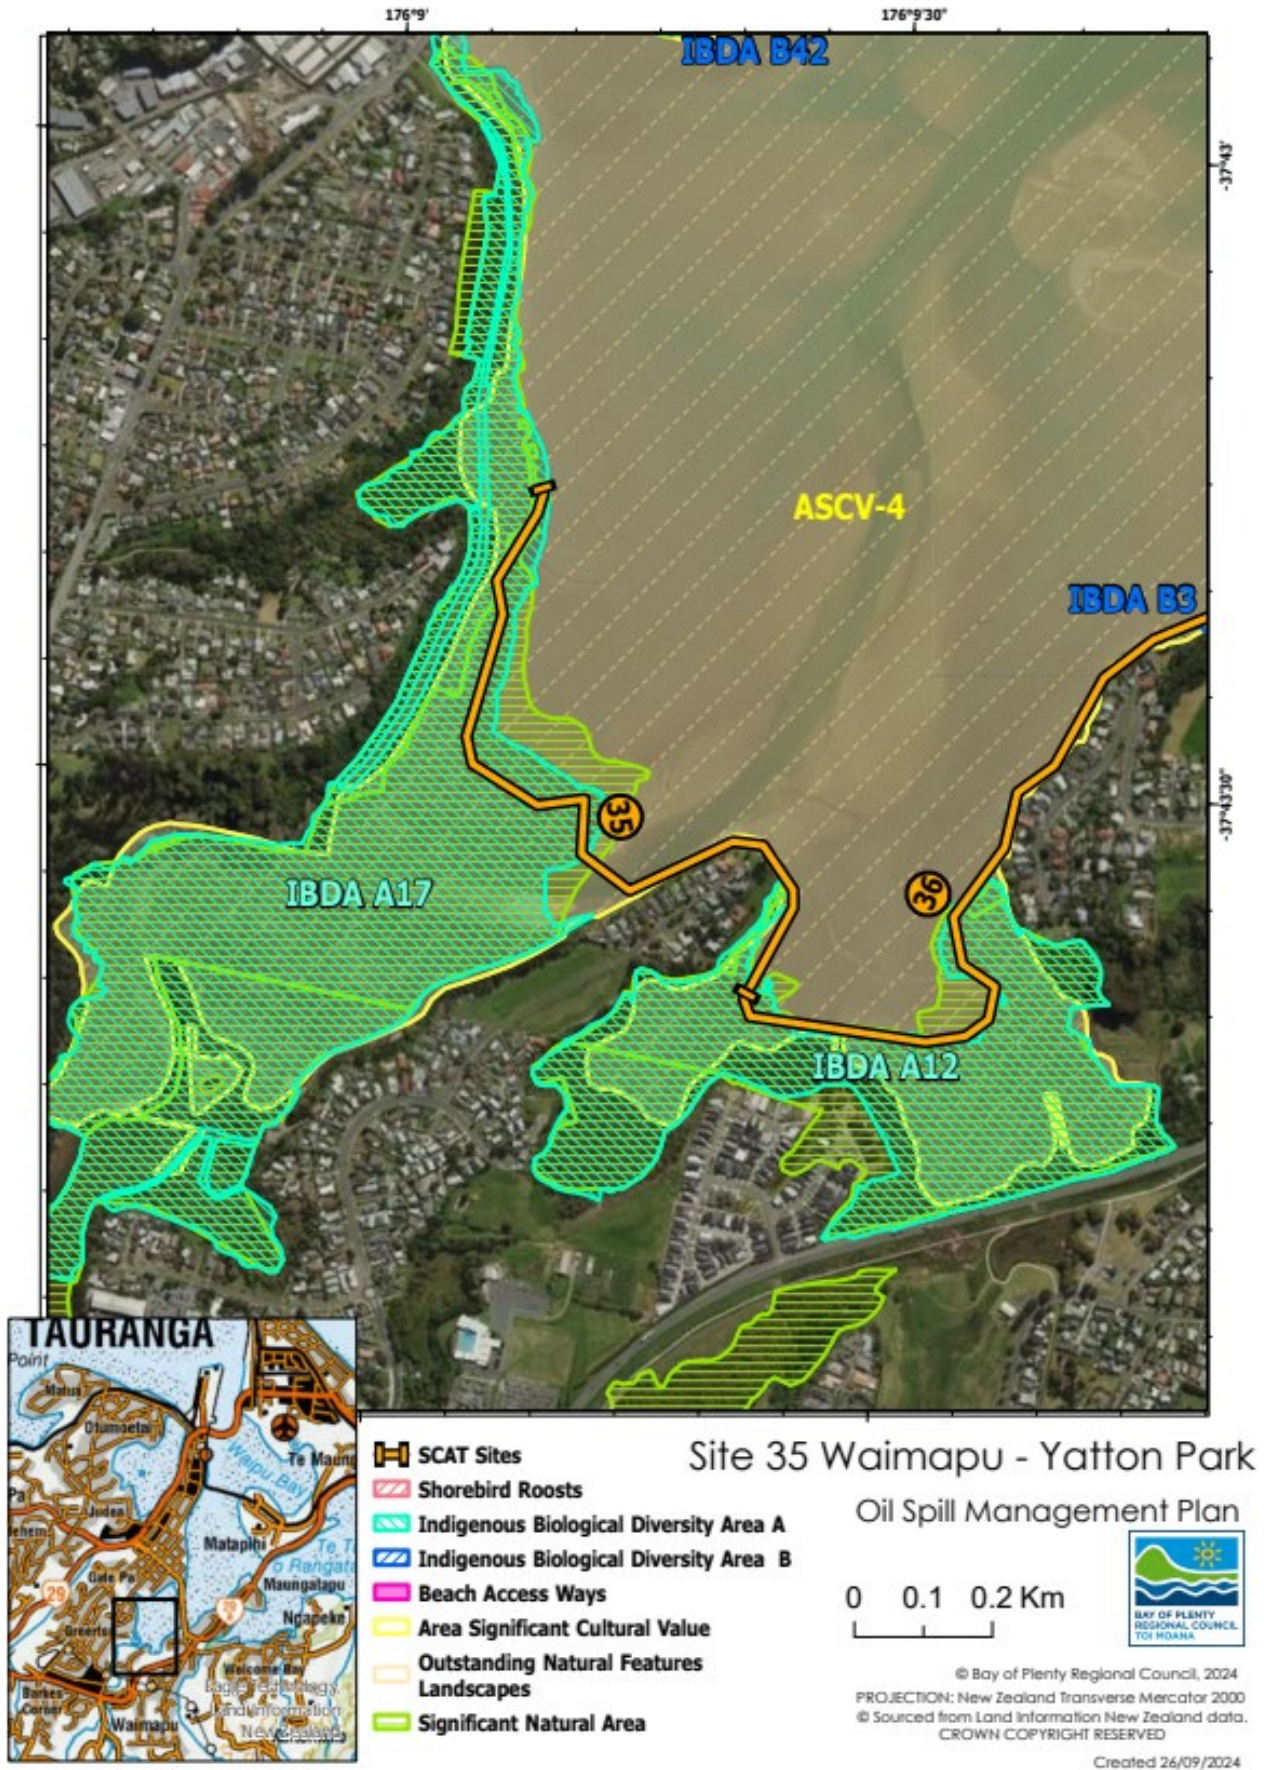
| <b>DESCRIPTION</b><br>Saltmarsh with mangrove around the perimeter and cliffs behind. There is a high energy river going through the middle of the site. The river is tidal up to the Oropi Golf Course. | | |
| <b>Access</b><br>Via Yatton Park/Fraser Street or Windermere Drive, access via the Bay of Plenty Polytechnic. Note deep mud in upper estuary. | | |

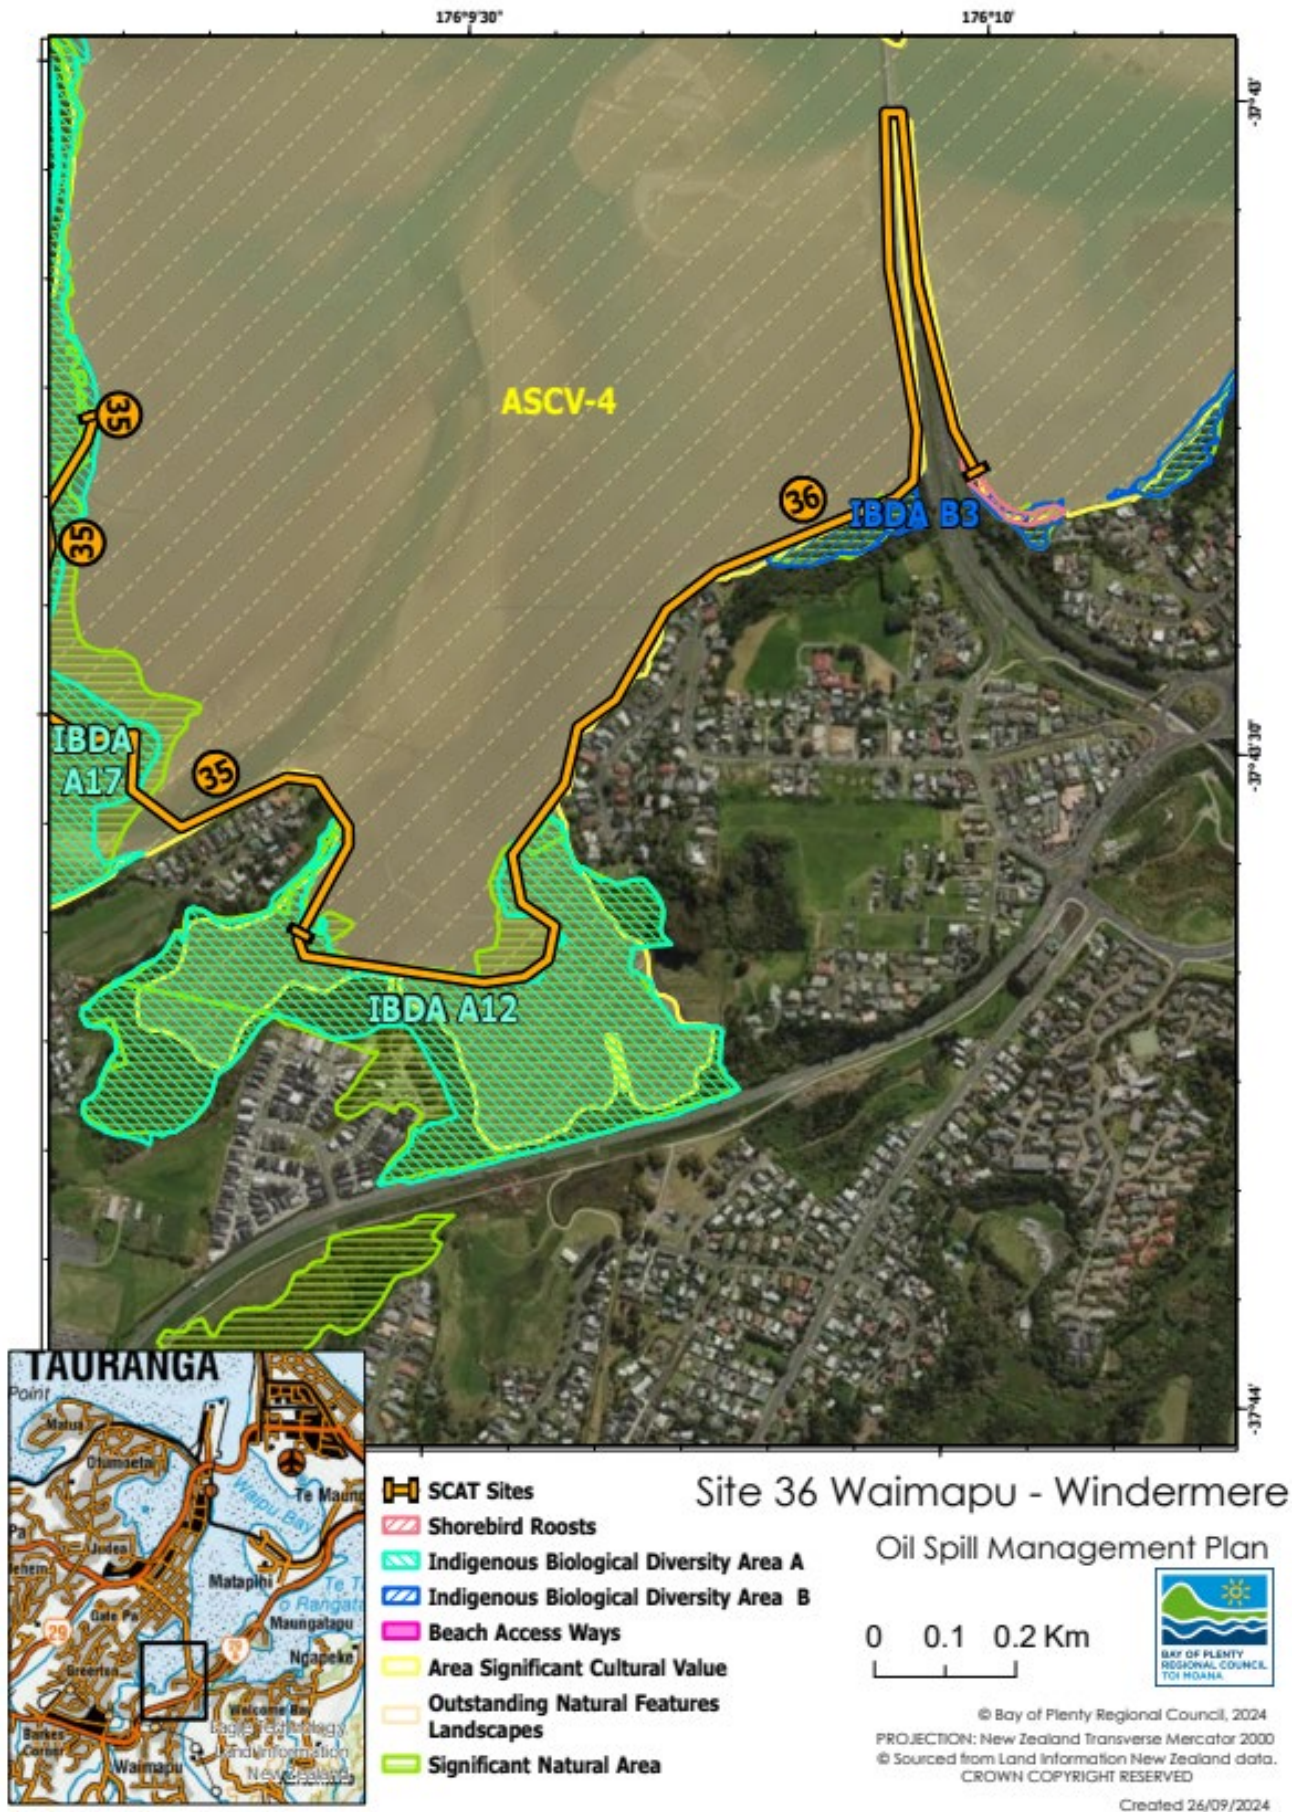
| Site 36 | Waimapu – Windermere | | Risk ranking: 3 |
|---|---|---|---|
| <b>DESCRIPTION</b><br>Saltmarsh with mangrove edge. Grey willow forest with an indigenous understory. Low energy intertidal mudflat. | | | |
| <b>Access</b><br>Via SH 29 through Sanctuary Point Motor Camp or via Turret Road through Silver Birch Motor Camp. | | | |
