| Site 49 | Herepuru Stream | Risk ranking: 3 |

| Site 50 | Matatā Lagoon | Risk ranking: 1 |

| Site 51 | Rangitaiki River East | Risk ranking: 1 |

| Site 52 | Whakatāne River/Estuary | Risk ranking: 2 |

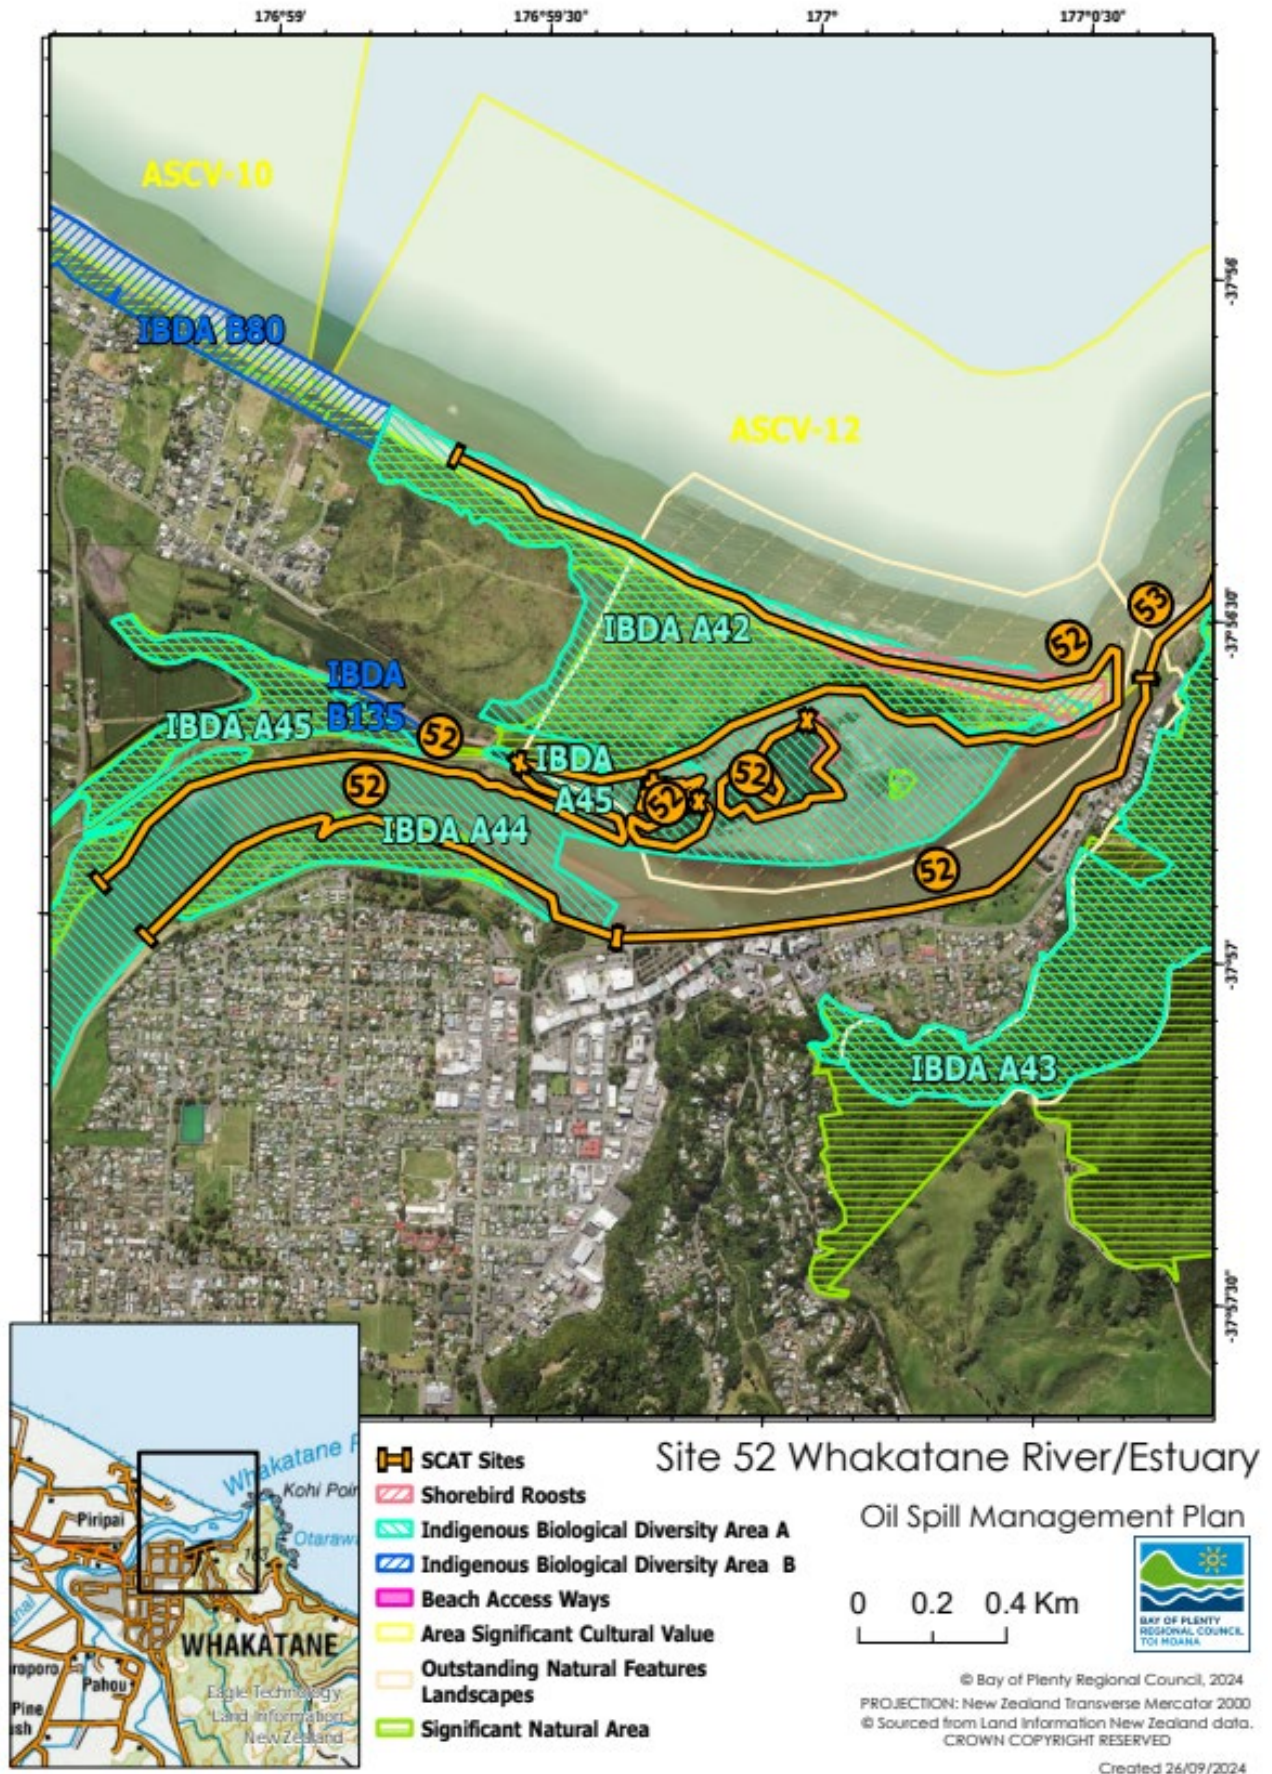
| Site 52 | Whakatāne River/Estuary | Risk ranking: 2 |
|---|---|---|
| <b>DESCRIPTION</b><br>This site comprises bar-built river mouth with tidal influence up to 5 km inland. A sandbar encloses small areas of saltmarsh and tidal open water lagoon. River is used for recreational and commercial boat access. The area is of significant spiritual significance to Ngāti Awa. | | |

- Limit the oil entering the saltmarsh habitat and lagoon to the south of the sand spit
- Investigate the flood control gate in lower reaches of the river and the feasibility of wedging shut the flap to prevent oil travelling up the Orini Canal on the tide
- Close floodgates and release water on out-going tide to help keep oil from moving up estuary, but close on incoming tide
- Foreshore cleaning on eastern shore to reduce remobilization of oil into river
- Decide on pre-emptive removal of beach branch debris at spit entrance. Note that access is problematic
- Notify wildlife team
- Discuss pre-clean-up of intertidal debris - tidal range specific – with wildlife
- Consider pre-emptive capture of New Zealand dotterel
- Consider pre-emptive capture of wildlife generally
- Activation of oiled wildlife response collection teams if required
- Investigate protecting paper mill intake
