| <b>Site 61</b> | <b>Kereu Rivermouth</b> | <b>Risk ranking: 3</b> |

| Site 62 | Raukokore River | Risk ranking: 3 |

| <b>Site 63</b> | <b>Orete Point</b> | <b>Risk ranking: 3</b> |

| Site 64 | Oruatiti and Waikanapanapa | Risk ranking: 3 |

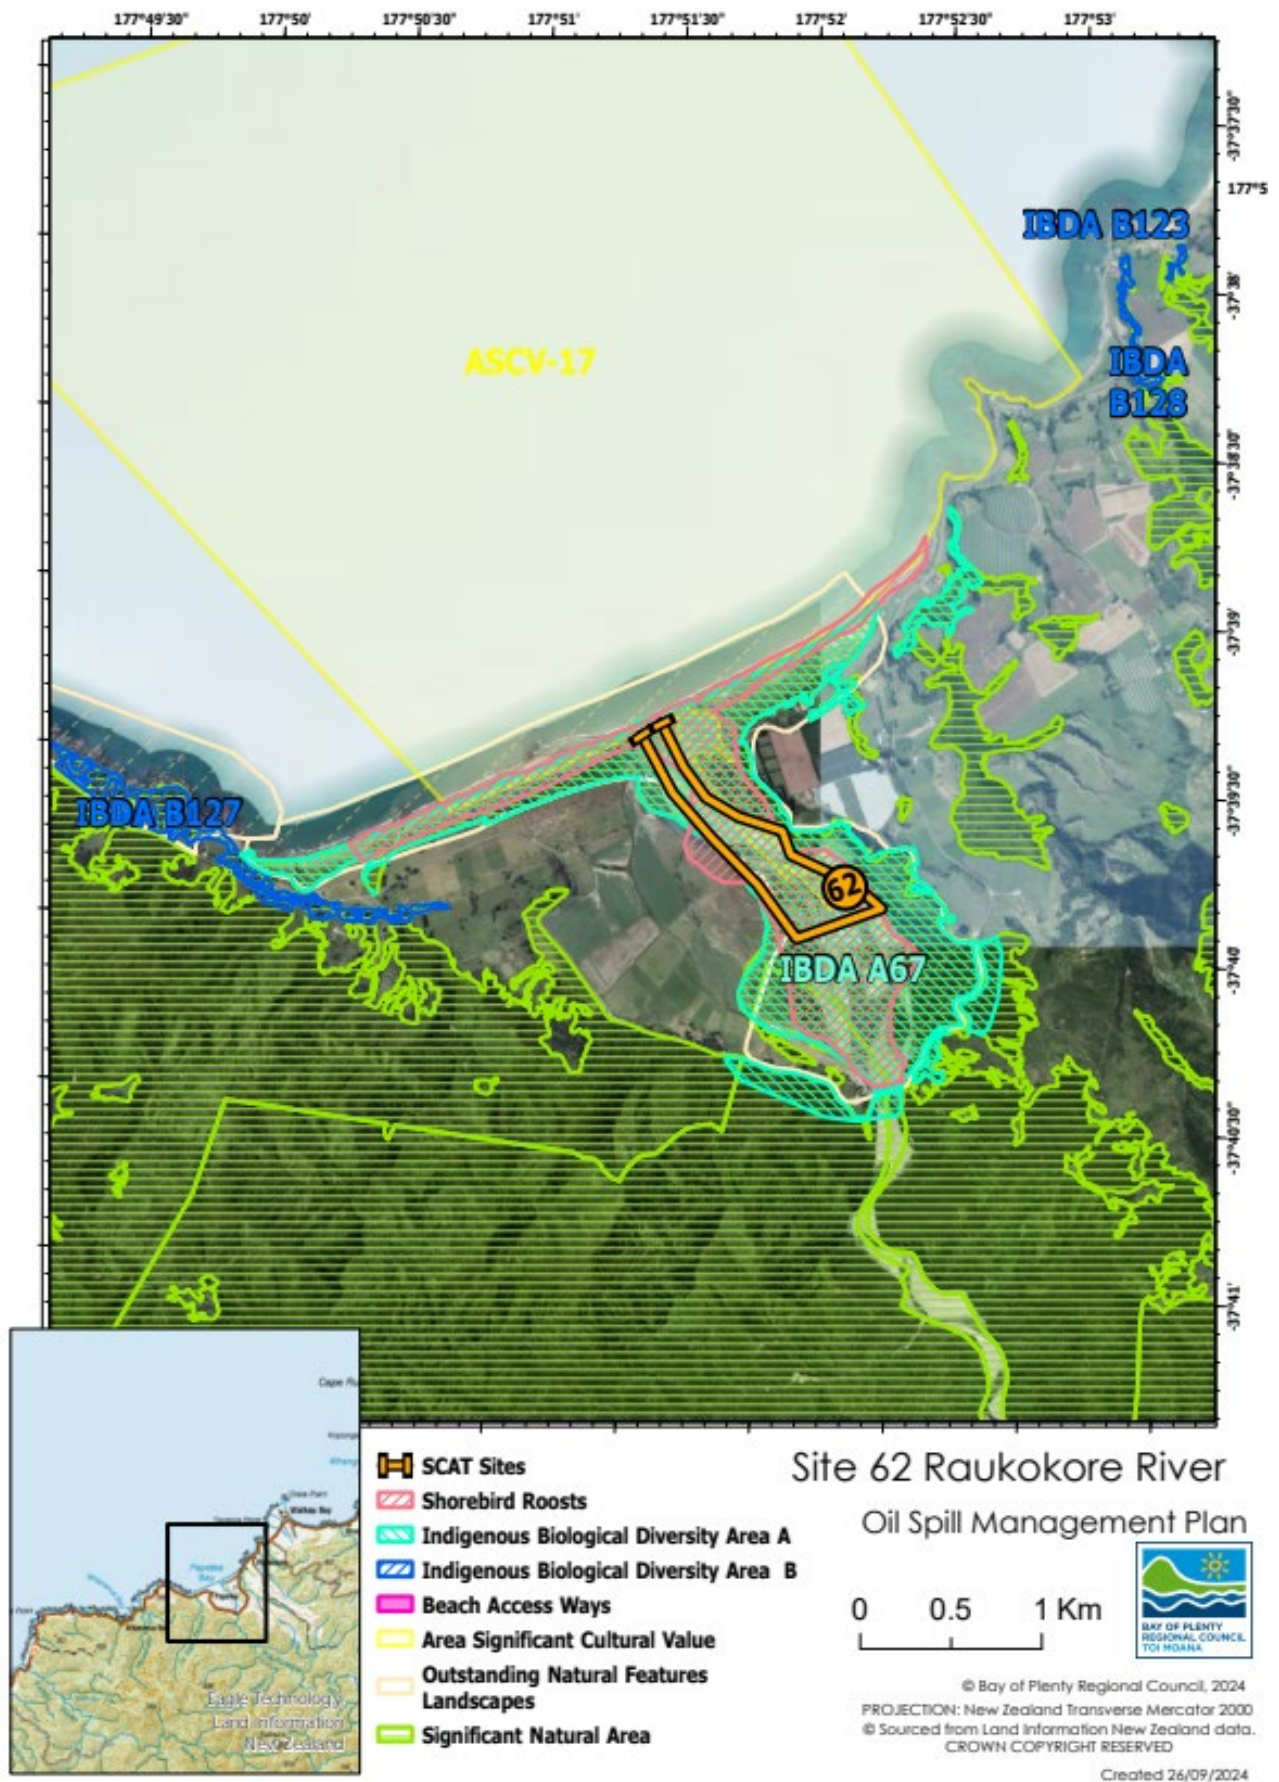
| Site 62 | Raukokore River | Risk ranking: 3 |
|---|---|---|
| <b>DESCRIPTION</b><br><p>This site is a sand spit enclosed estuary. Generally a low flow river with a small mouth/entrance that is open at higher tide states, forming a lagoon behind the spit with associated saltmarsh. This site forms part of the Raukōkore Mātaitai reserve in the coastal marine area, and the Raukokore River mouth is identified as an Outstanding Natural Feature and Landscape (ONFL 36).</p> <p>Sand spits and beaches are pebble/cobble.</p> | | |
| <b>Access</b><br><p>Access to beach areas and the Ruakokore Rivermouth is indicated on the topographical map, SH 35: access to the west is across farmland; to the east by access track from Cemetery Road.</p> | | |

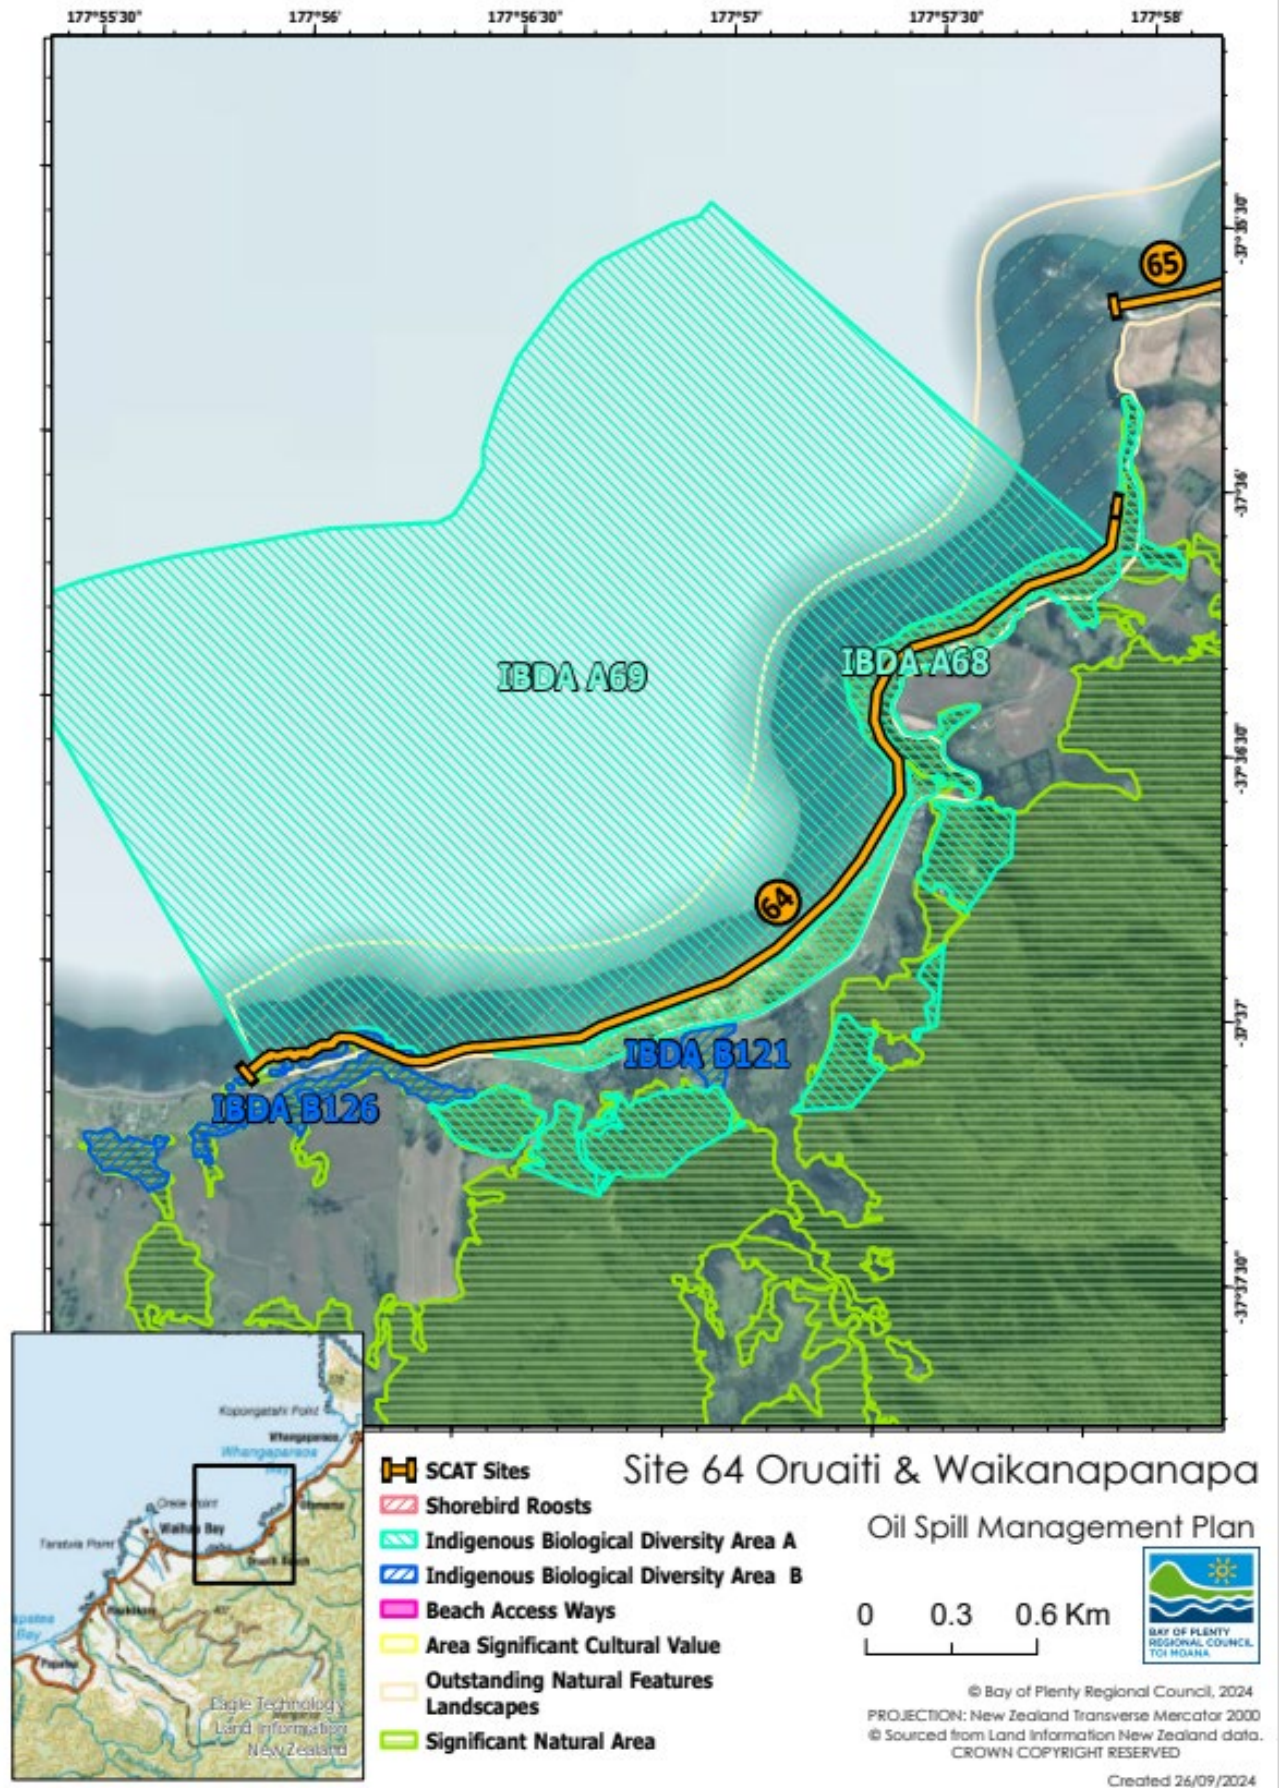
| <b>DESCRIPTION</b><br>The site is located to the east of Waihou Bay. The site comprises of wave cut platforms which have significant coastal landscape values. Oruaiti Beach the offshore rocks and Waikanapanapa cliffs are identified as an Outstanding Natural Feature and Landscape (ONFL 37). It is the only example of intertidal and subtidal area on a Miocene age soft rock substrate in the Bay of Plenty. | | |
| <b>Access</b><br>Road access to the sites is via SH 35 as indicated on the topographical map. The nearest boat launching ramp is Waihou Bay. | | |
