| Site 13 | Aongatete | Risk ranking: 2 |

| Site 14 | Wainui | Risk ranking: 2 |

| Site 15 | Central Mangroves | Risk ranking: 3 |

| Site 16 | Te Hopai | Risk ranking: 3 |

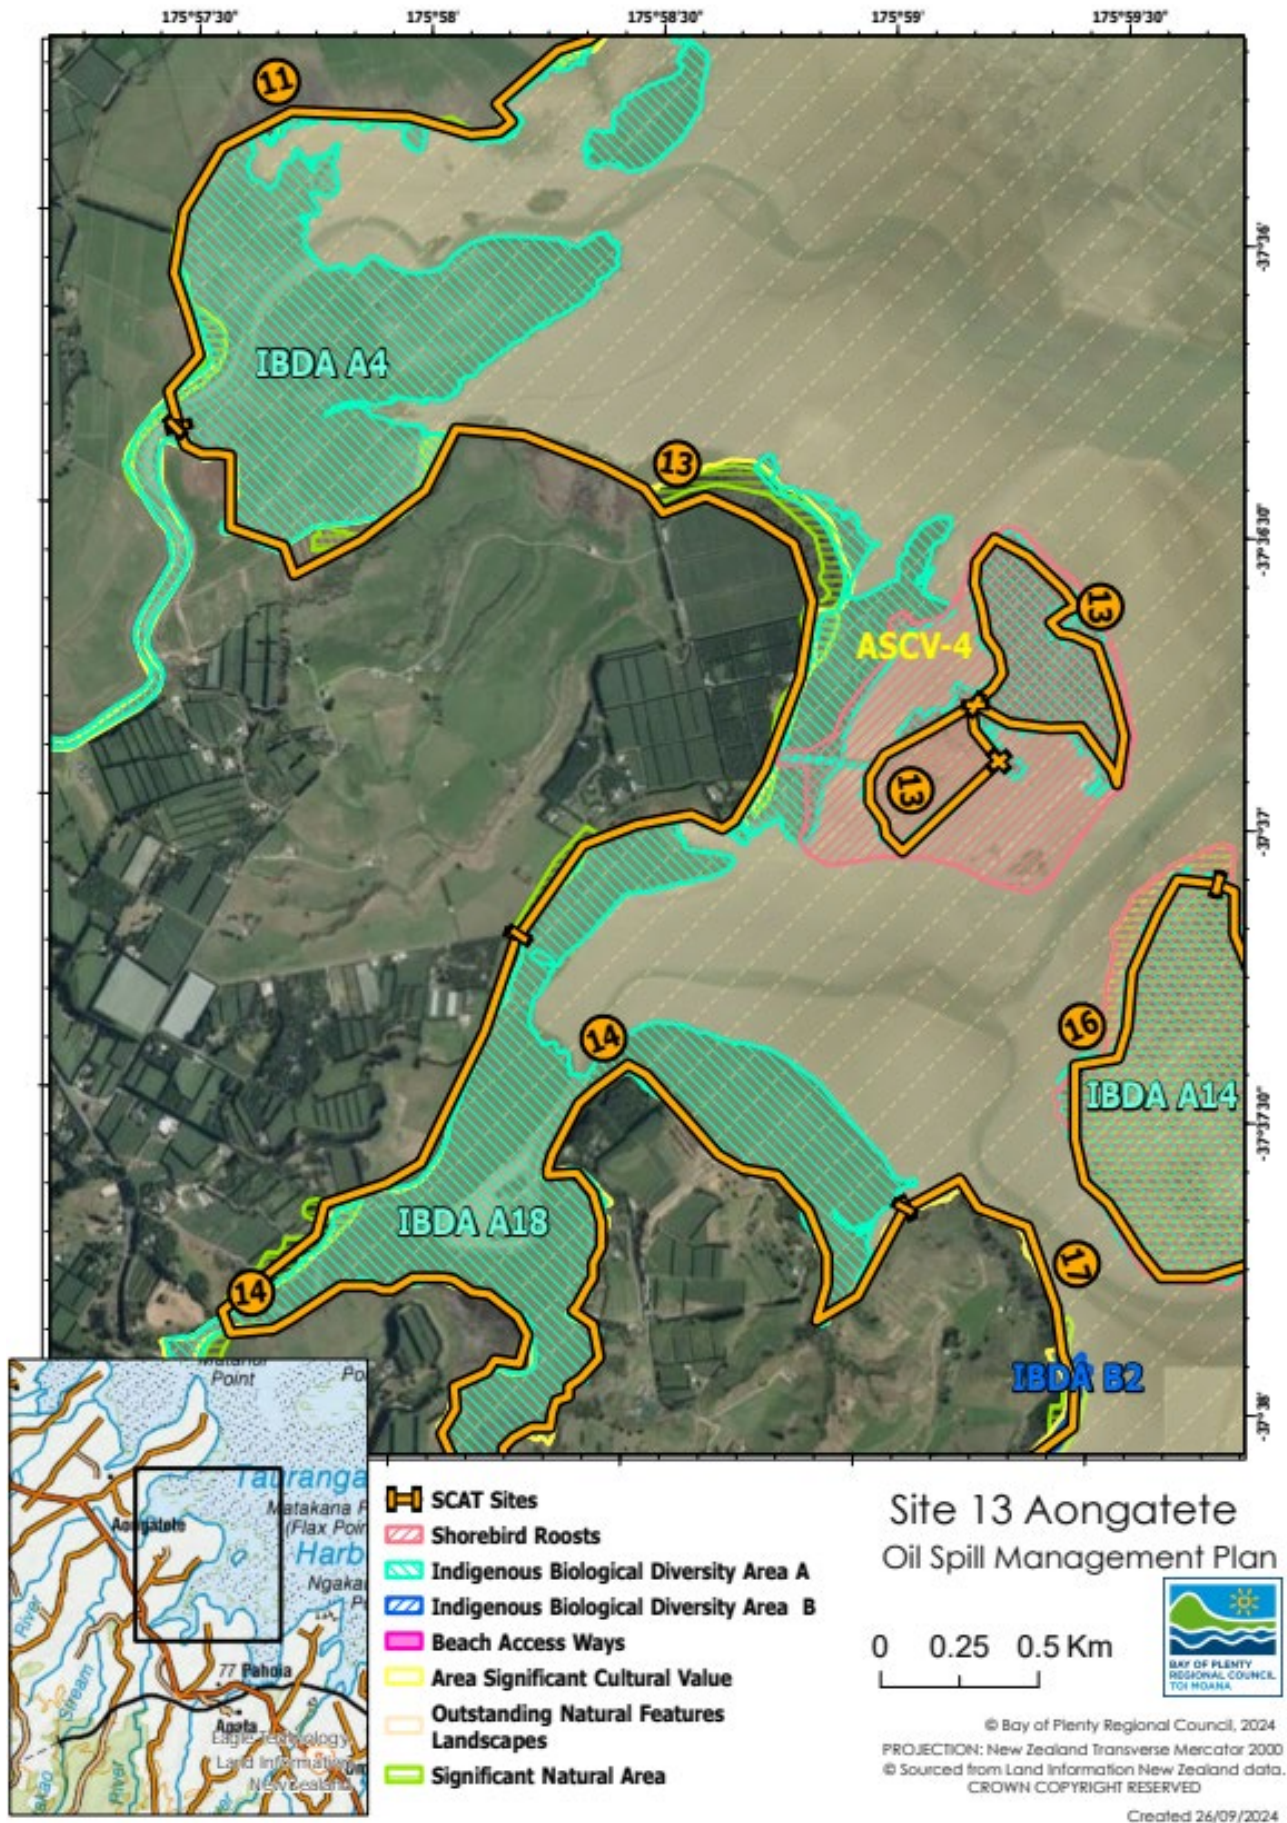
| <b>DESCRIPTION</b><br>Low energy, saltmarsh and mangrove. Aongatete Estuary contains large areas of representative mangrove stands, which are diverse in stature and density. These stands are contiguous with saltmarsh of high quality characteristic of Tauranga Harbour. | | |
| <b>Foreshore type/environmental value</b> | Intertidal sandflats, saltmarsh, mangroves. All shore segments have “habitat value”<br><br>All intertidal areas in Tauranga Harbour are identified as Areas of Significant Cultural Value (ASCV 4) Indigenous Biological Diversity Area A4 and A18 | |

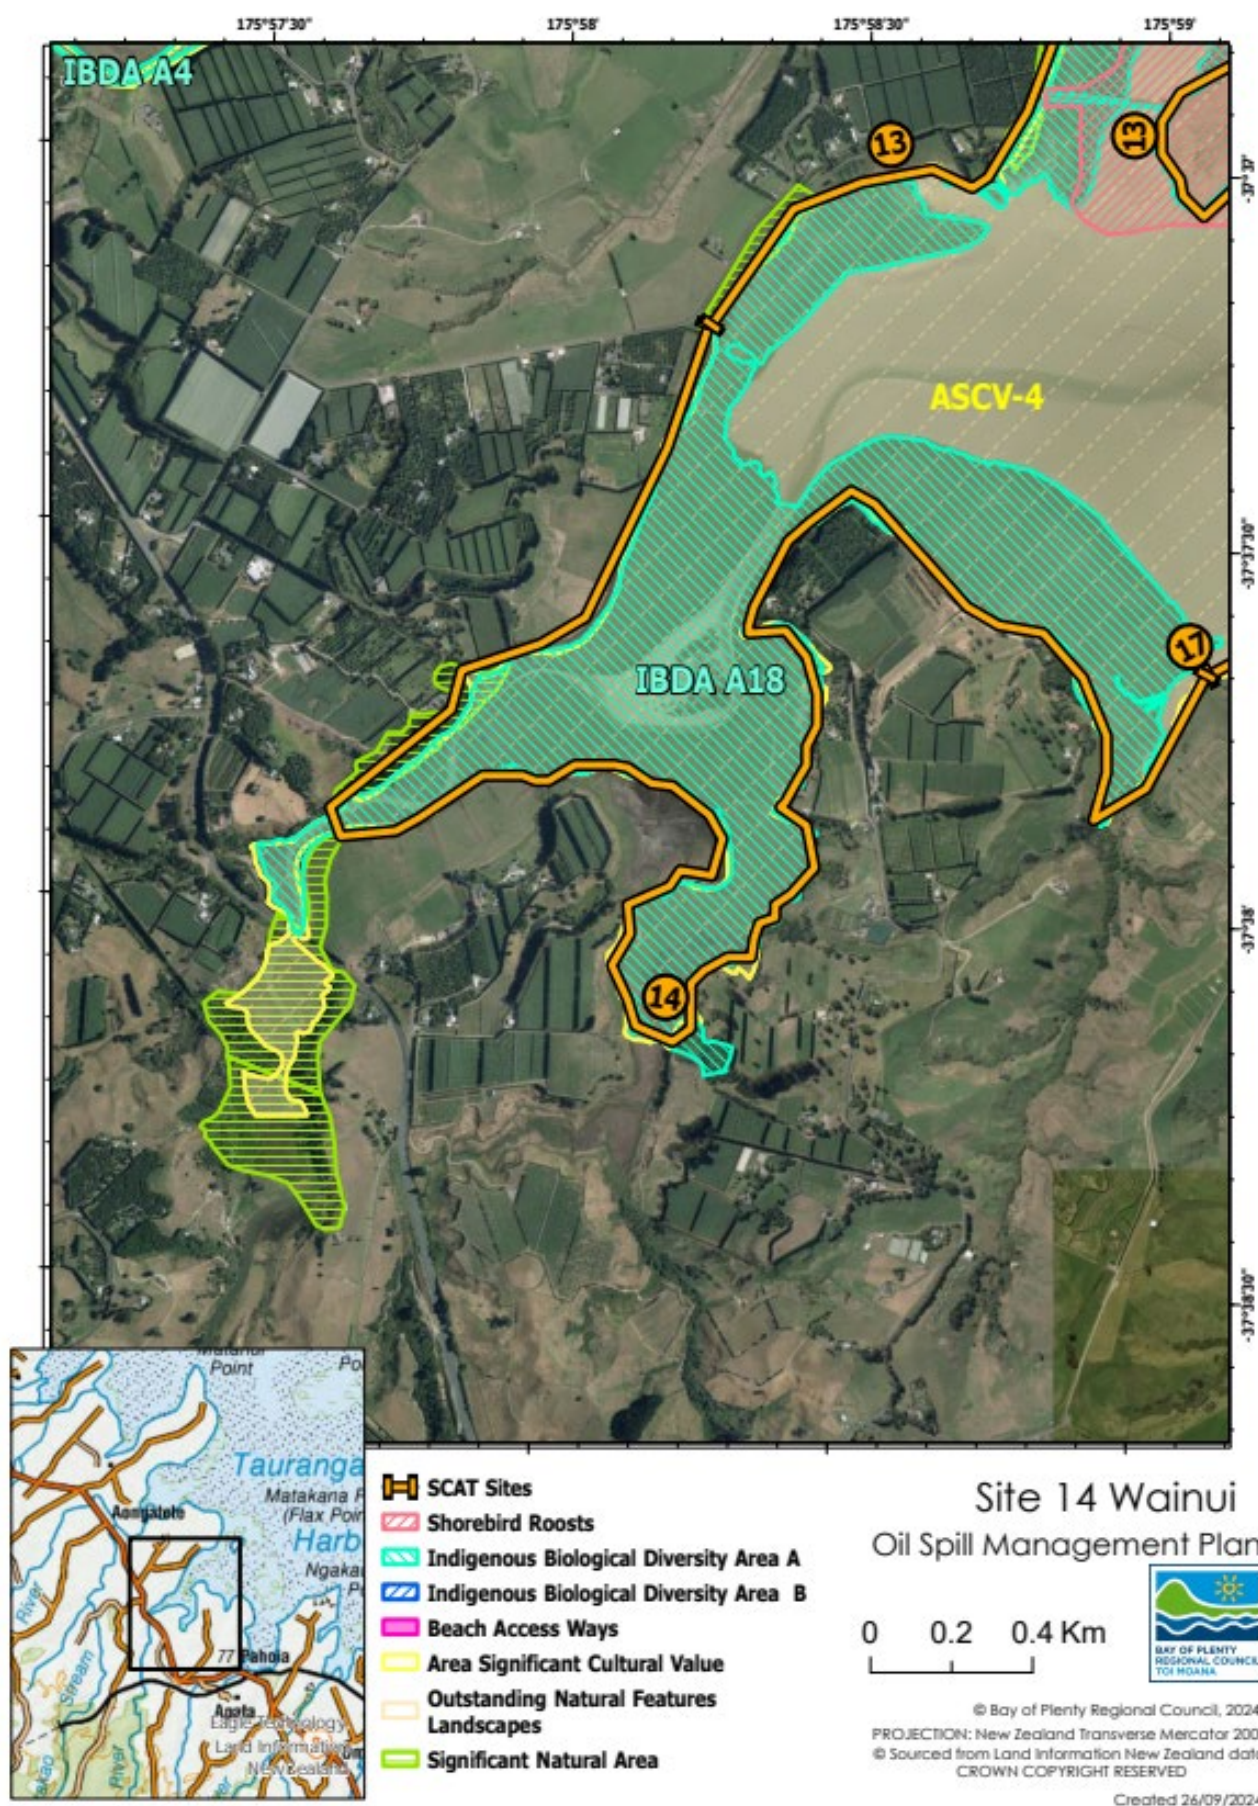
| <b>DESCRIPTION</b><br>This area is a relatively large, good quality example of wetland vegetation types, which are characteristic of Tauranga Harbour. This site contains representative examples of oioi sedgeland inland from the main harbour adjacent to a tidal stream, and manuka-raupo-toetoe shrubland, characteristic of Tauranga Harbour. | | |
| <b>Foreshore type/environmental value</b> | Intertidal sandflats, saltmarsh, mangroves. All intertidal areas in Tauranga Harbour are identified as Areas of Significant Cultural Value (ASCV 4) Indigenous Biological Diversity Area A18 | |

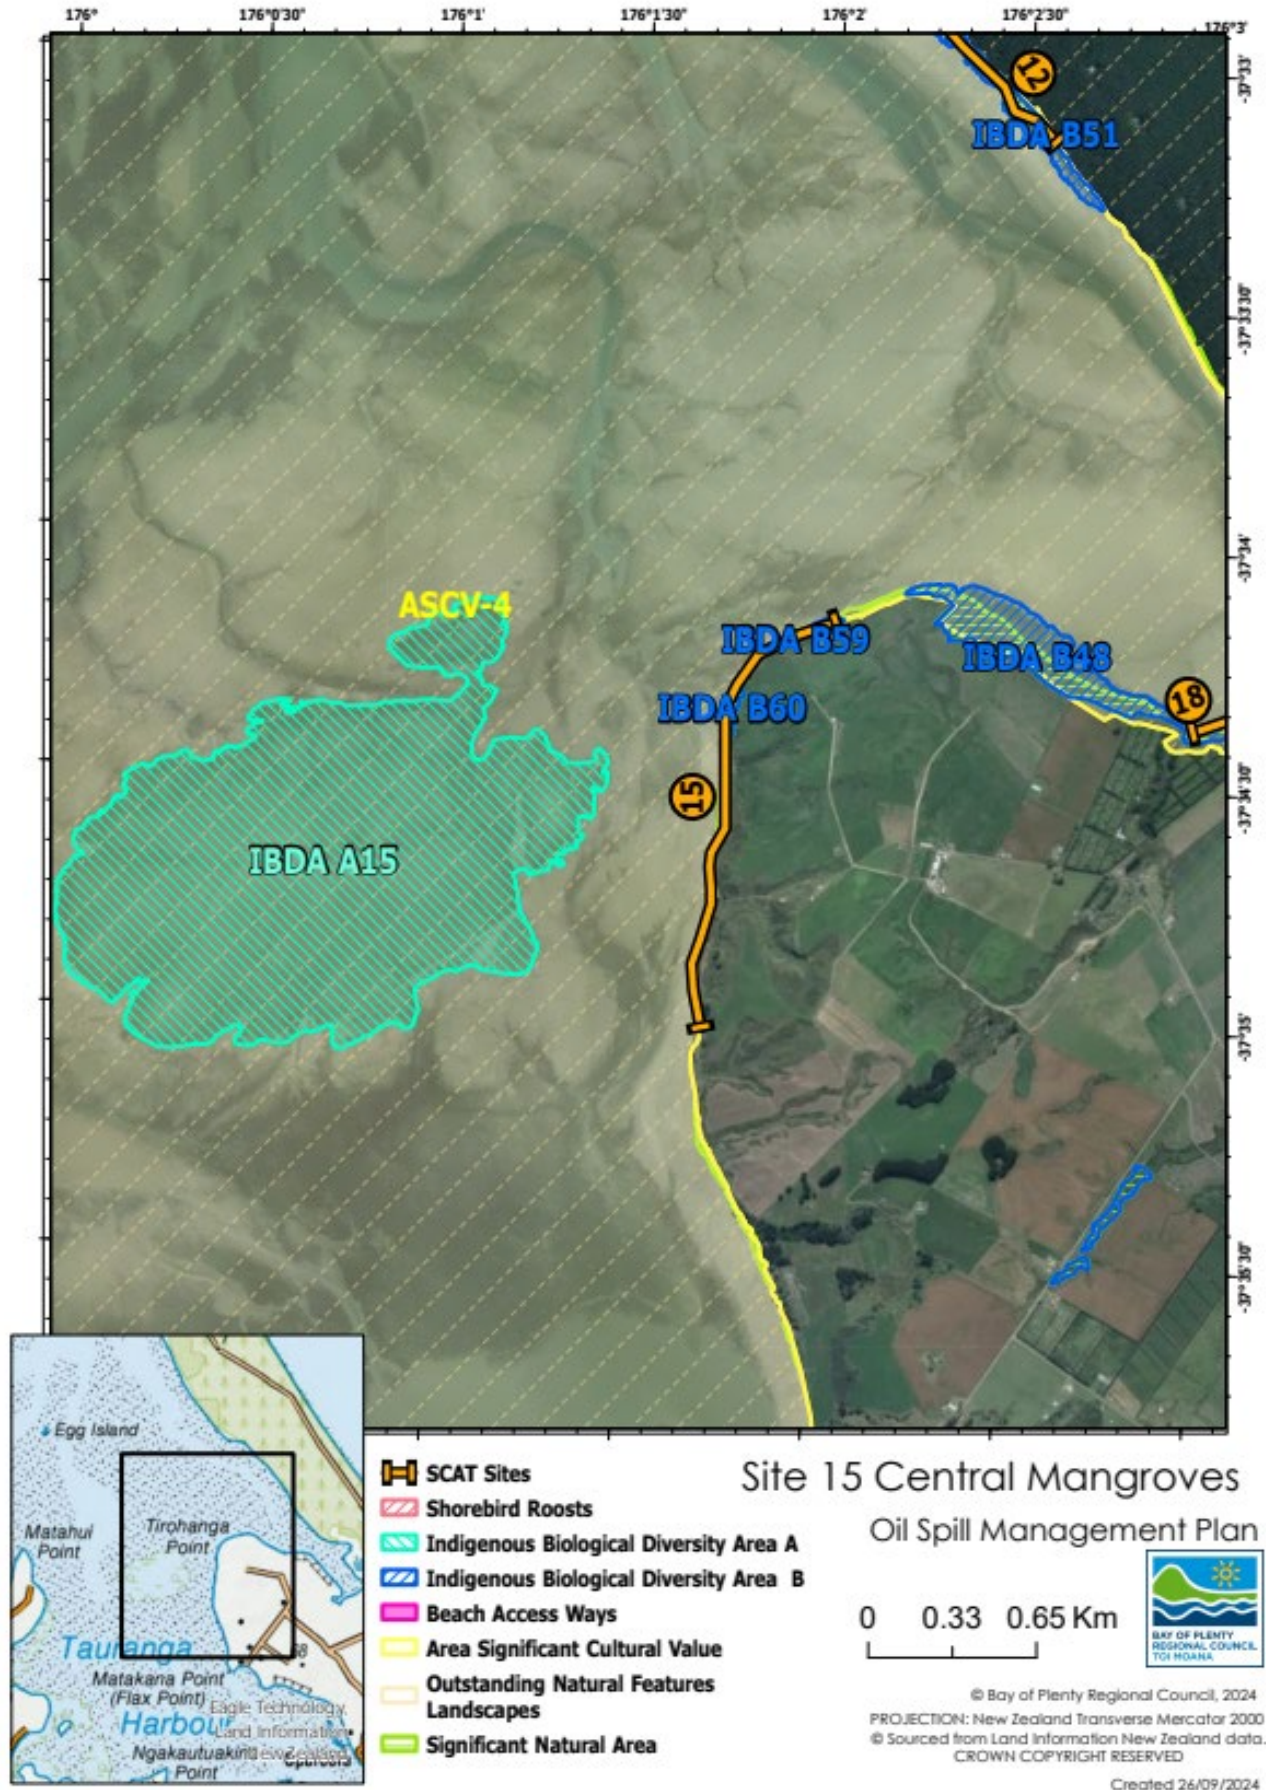
| Site 15 | Central Mangroves | Risk ranking: 3 |
|---|---|---|
| <b>DESCRIPTION</b><br>Largest area of mangroves in harbour, with some manuka shrublands in centre. Situated in central middle of harbour on western side of Matakana Island.<br>Moderate energy tidal flow. | | |
| <b>Foreshore type/environmental value</b> | Intertidal sandflats, saltmarsh, mangroves, seagrass transitional ecosystem (island in the making)<br>All shore segments have “habitat value”<br>All intertidal areas in Tauranga Harbour are identified as Areas of Significant Cultural Value (ASCV 4) Indigenous Biological Diversity Area A15, B59 and B60 | |

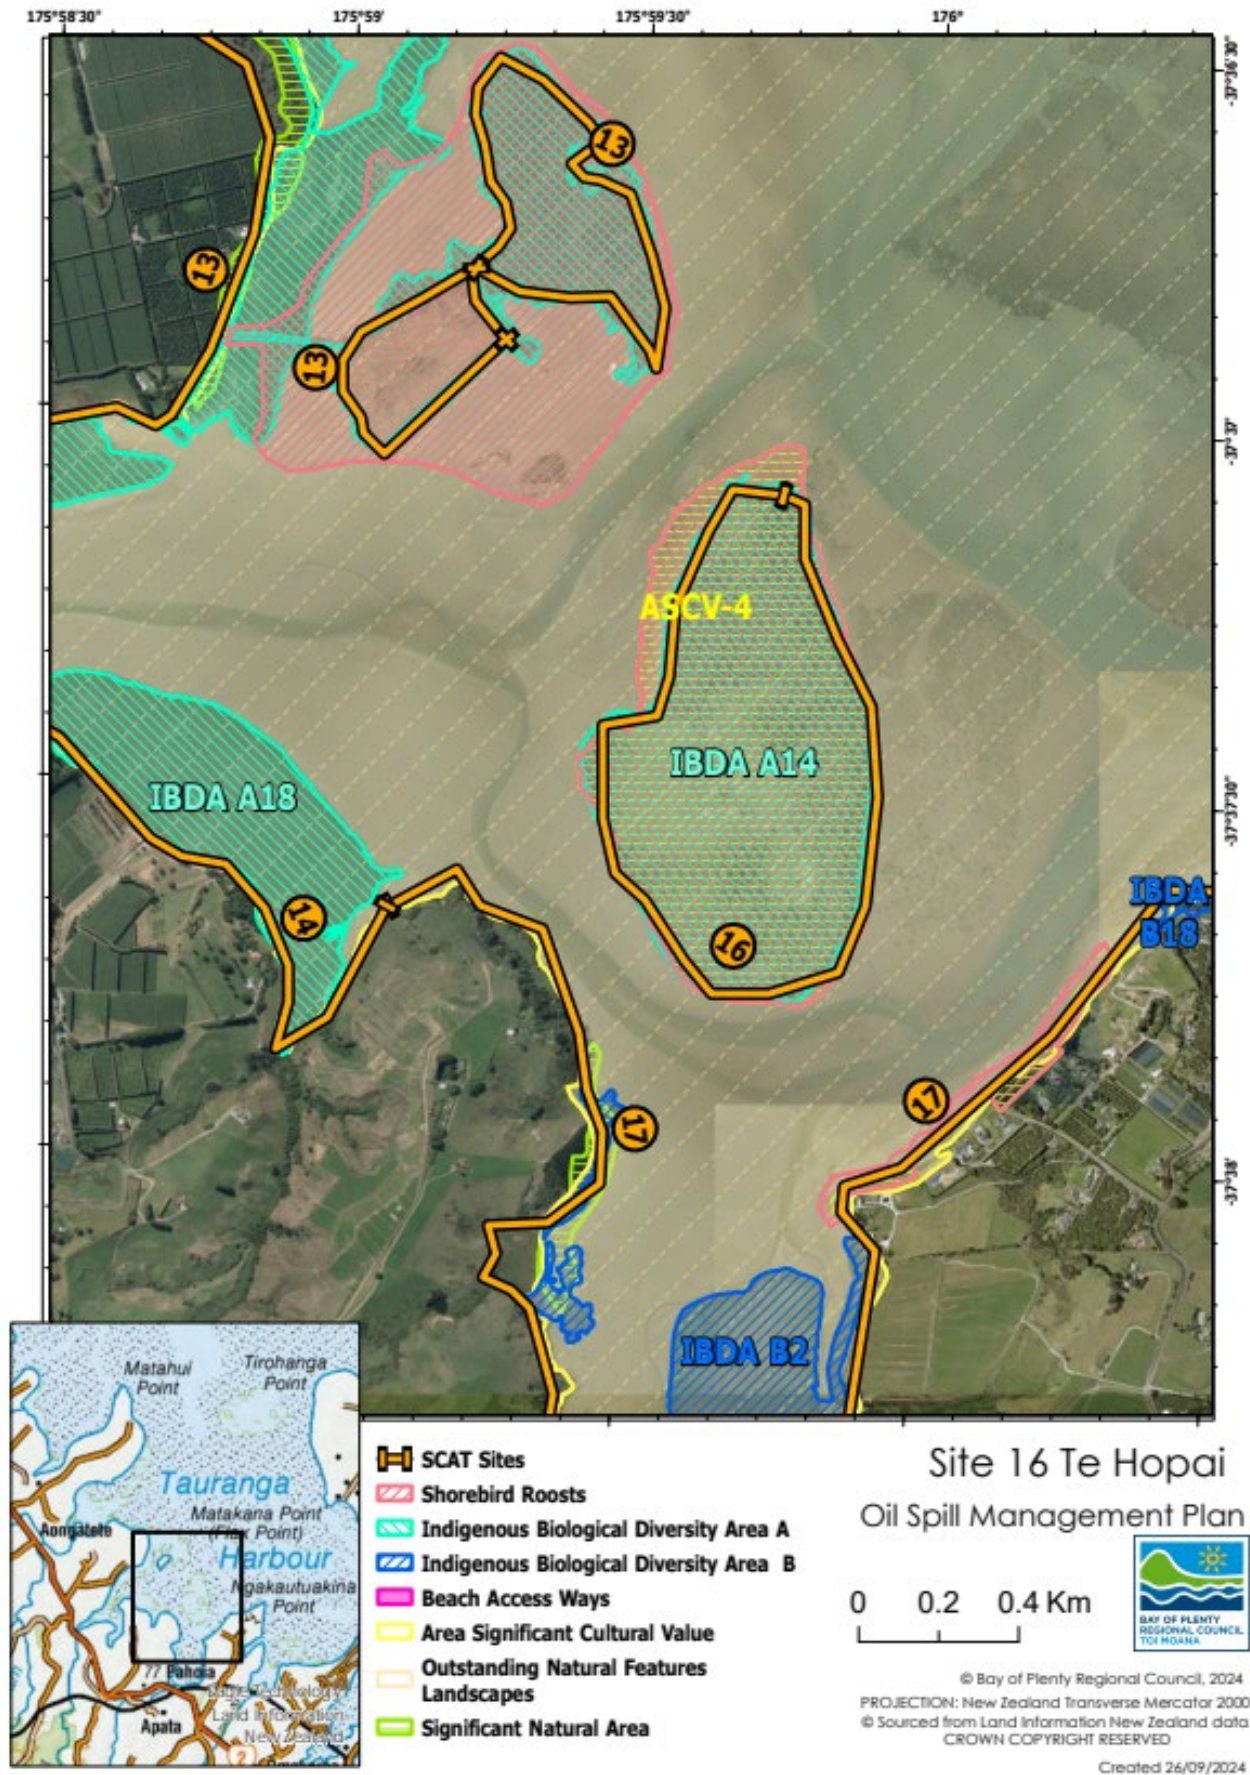
| <b>DESCRIPTION</b><br>Large area of saltmarsh and ribbon wood located approximately 1 km southeast of Te Hopai Island within the Tauranga Harbour. | | |
| <b>Foreshore type/environmental value</b> | Intertidal sandflats, saltmarsh, mangroves, seagrass<br>All intertidal areas in Tauranga Harbour are identified as Areas of Significant Cultural Value (ASCV 4) Indigenous Biological Diversity Area A14 | |
