| Site 05 | Uretara Upper | Risk ranking: 1 |

| Site 06 | Uretara East | Risk ranking: 2 |

| Site 07 | Waikoura Point | Risk ranking: 1 |

| Site 08 | Rereatukahia | Risk ranking: 2 |

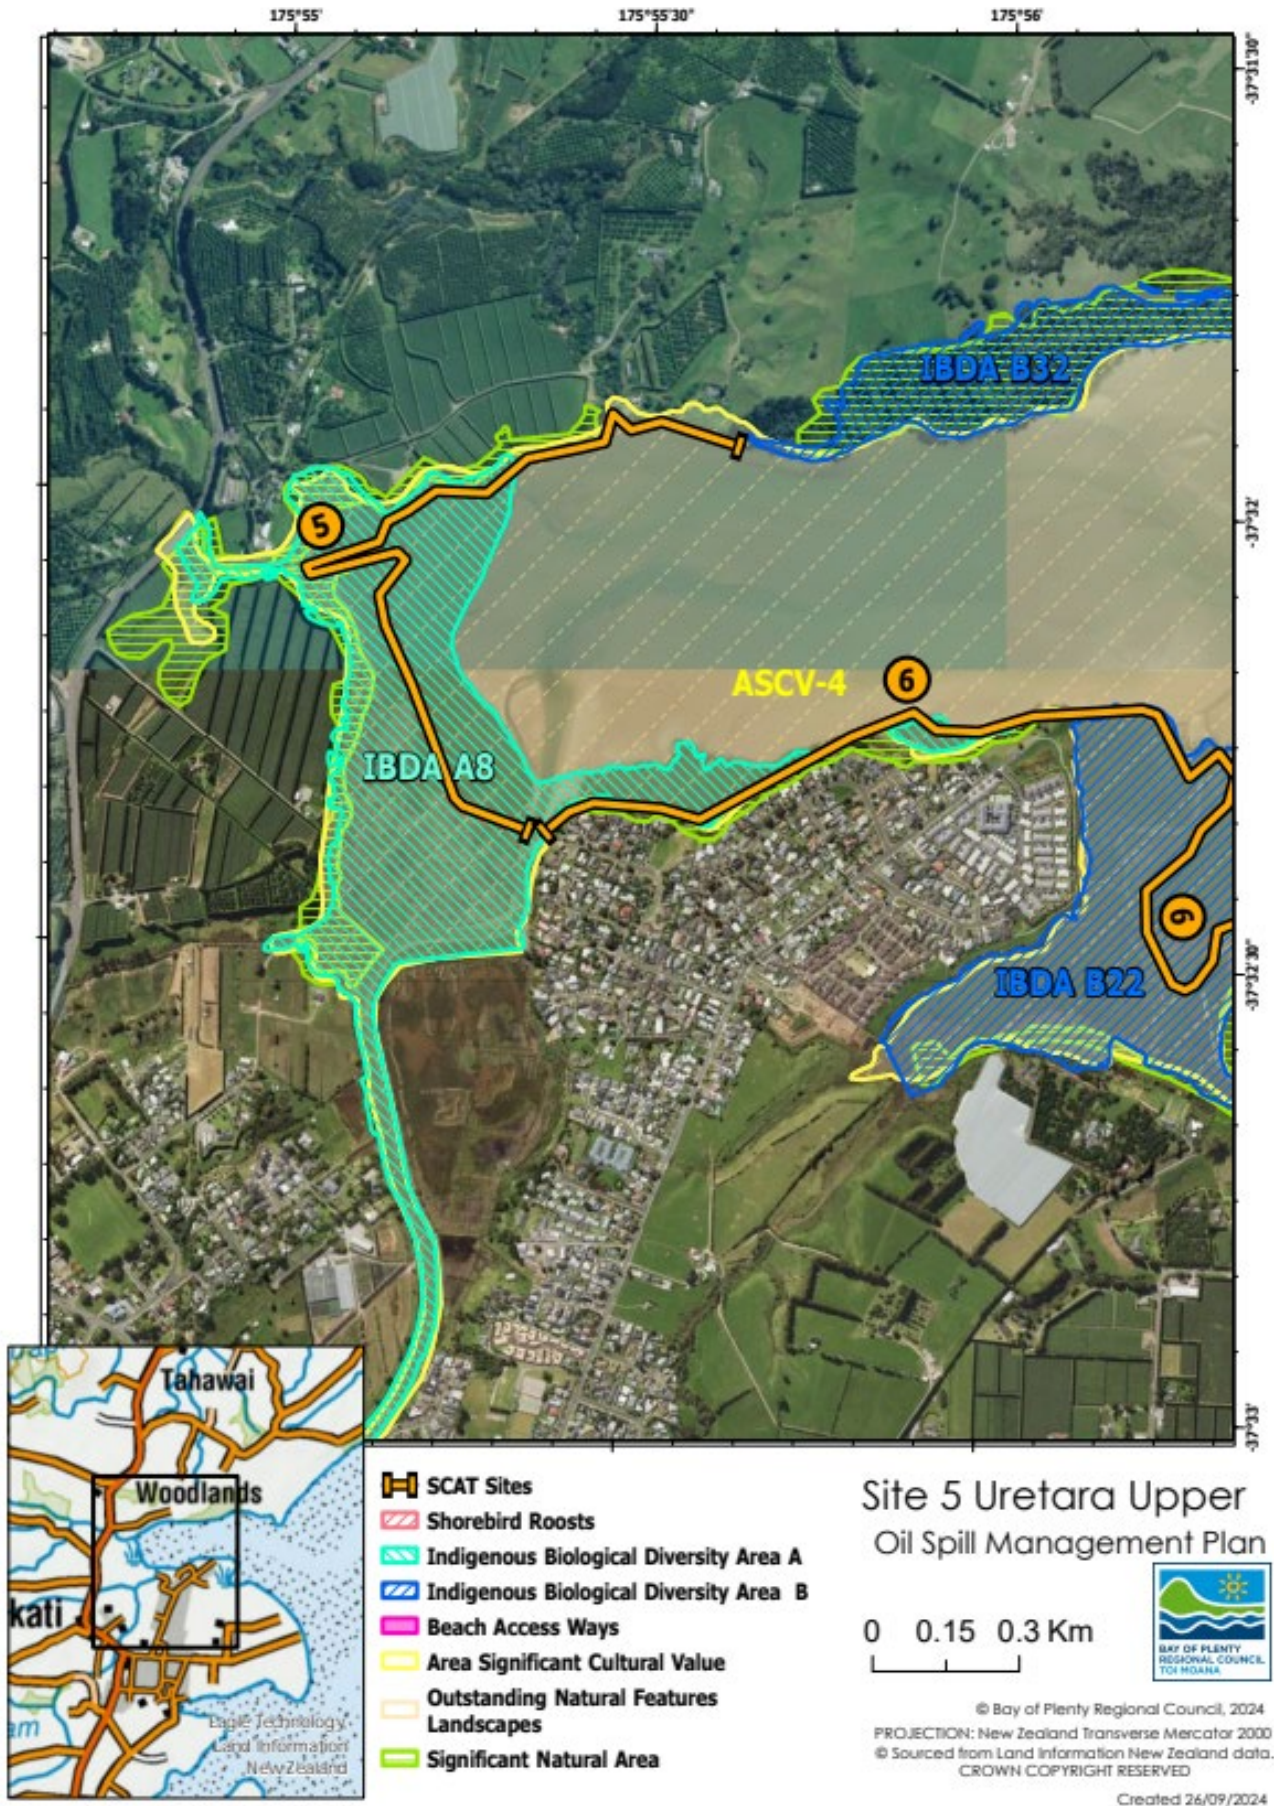
| <b>DESCRIPTION</b><br>Saltmarsh with mangrove edge, low energy, tidal up to Katikati. High quality example of estuarine and palustrine wetlands. | | |
| <b>Foreshore type/environmental value</b> | Intertidal sandflats, saltmarsh, mangroveAll intertidal areas in Tauranga Harbour are identified as Areas of Significant Cultural Value (ASCV 4) Indigenous Biological Diversity Area A8 | |
| <b>Access</b> <ul style="list-style-type: none"><li>Good vehicle access from SH 2 downstream</li><li>Foot access out into harbour</li></ul> | | |

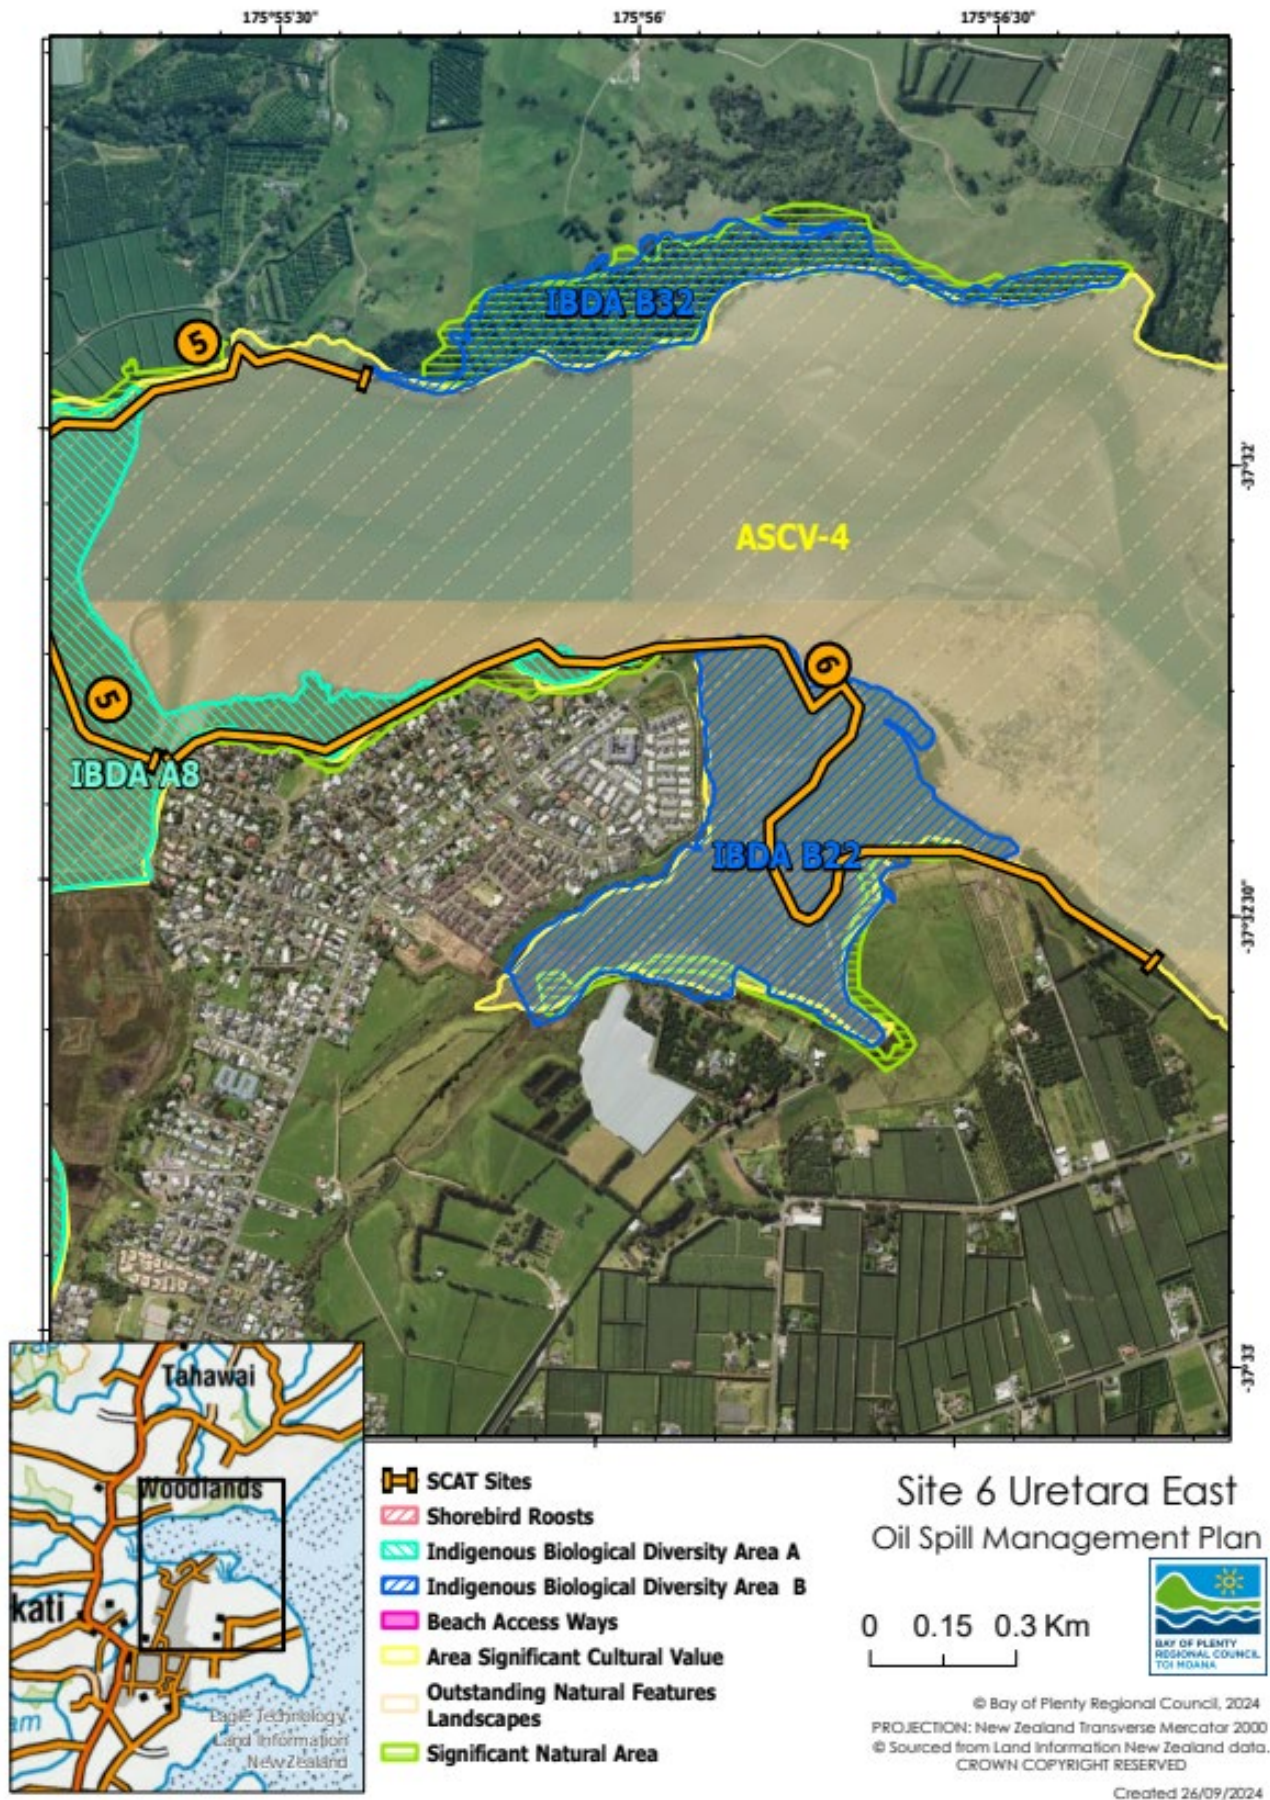
| <b>DESCRIPTION</b><br>The area to the east of Uretara Stream is a relatively large area of mangrove with small areas of saltmarsh. Sub-tidal low energy site. | | |
| <b>Foreshore type/environmental Value</b> | Intertidal sandflats, saltmarsh, mangroves, seagrass<br>All intertidal areas in Tauranga Harbour are identified as Areas of Significant Cultural Value (ASCV 4)<br>Indigenous Biological Diversity Area B22 | |
| <b>Access</b><br>Foot via Park Road, Katikati access. Access may be difficult or limited during high tide states. | | |

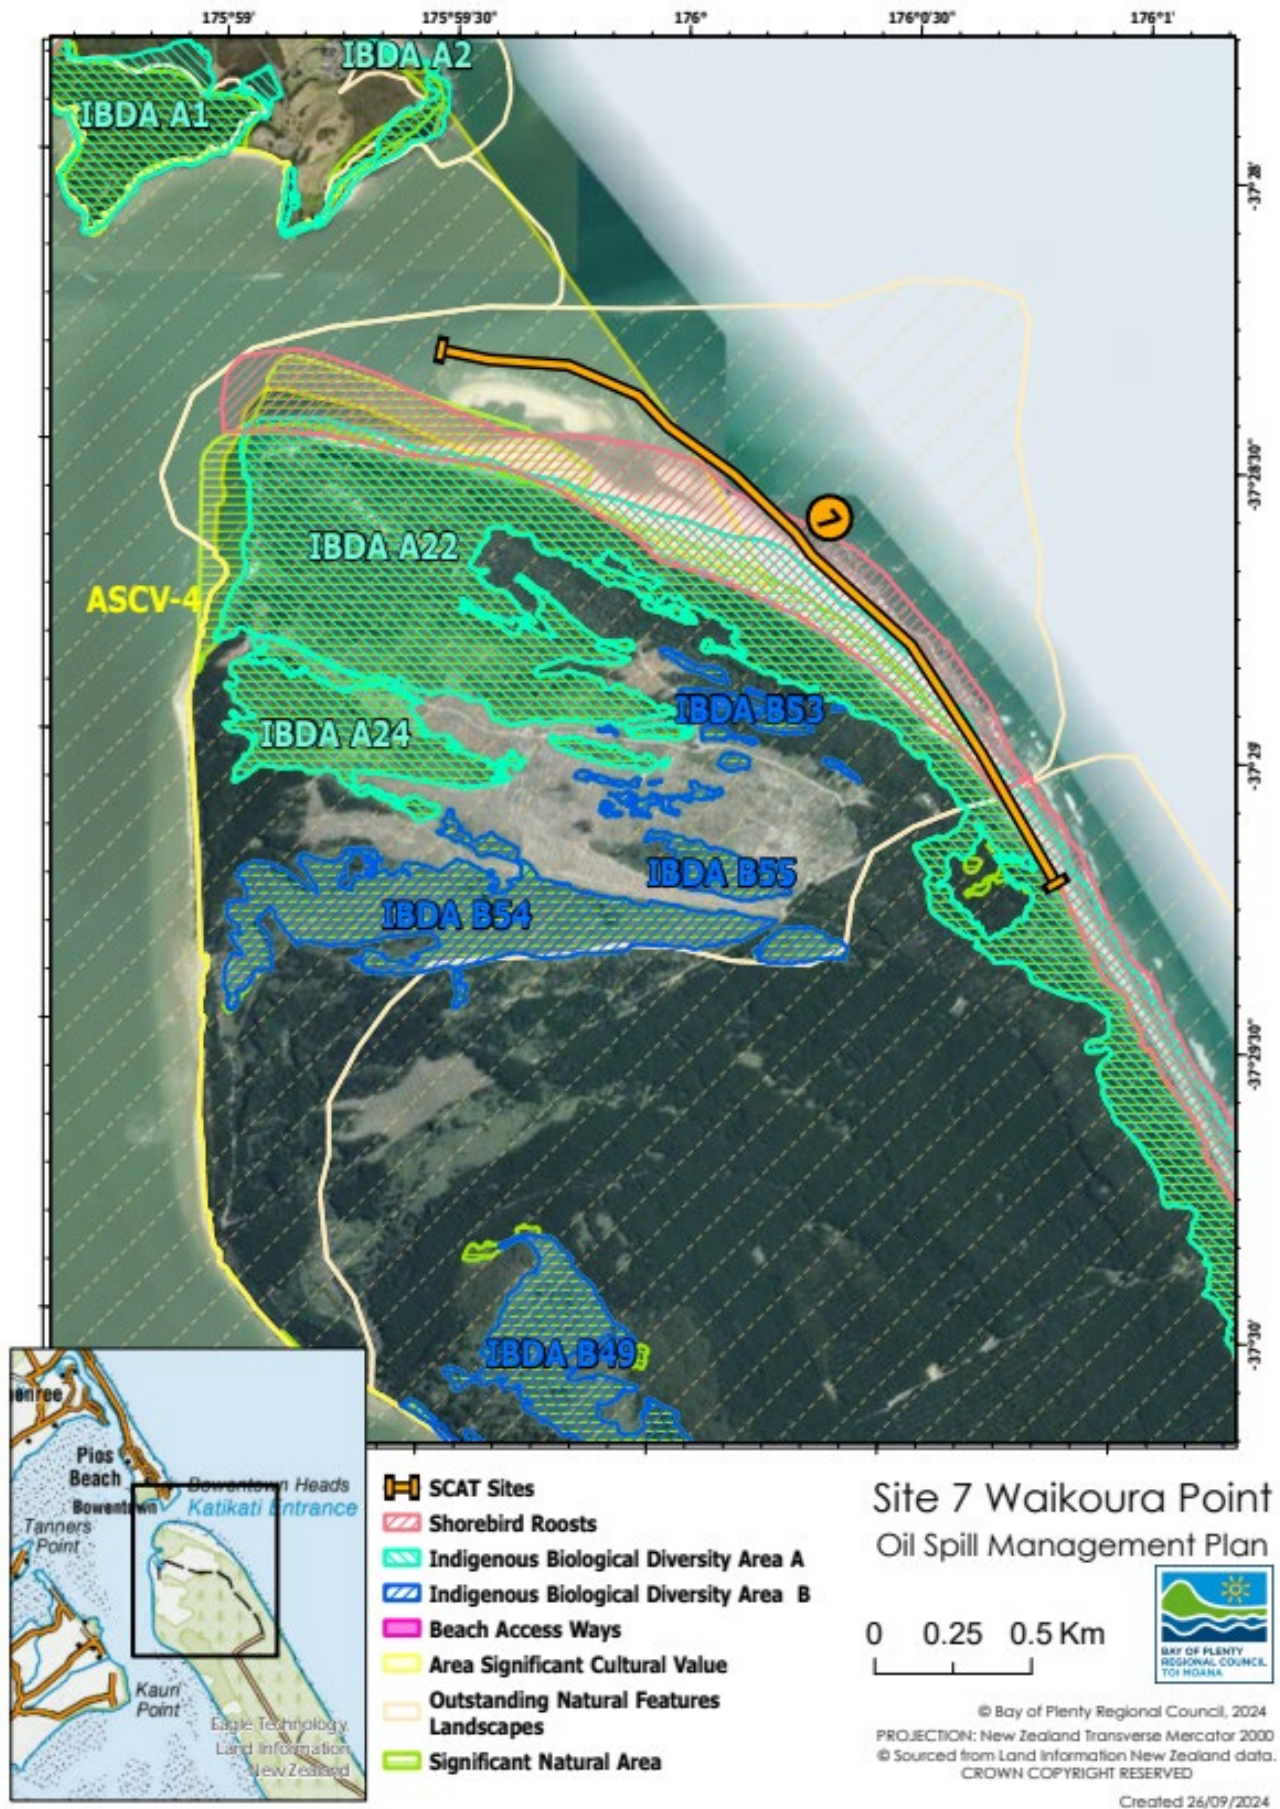
| Site 07 | Waikoura Point | Risk ranking: 1 |
|---|---|---|
| <b>DESCRIPTION</b><br>Northern end of Matakana Island | | |
| <b>Foreshore type/environmental value</b> | Dunes, Sandy beach<br>All shore segments have “habitat value”<br>High quality examples of an intact foredune contiguous with a wetland and a small dune lake.<br>Indigenous Biological Diversity Area A22 | |
| <b>Access</b><br>Boat and 4wd vehicle access through Matakana Island. | | |

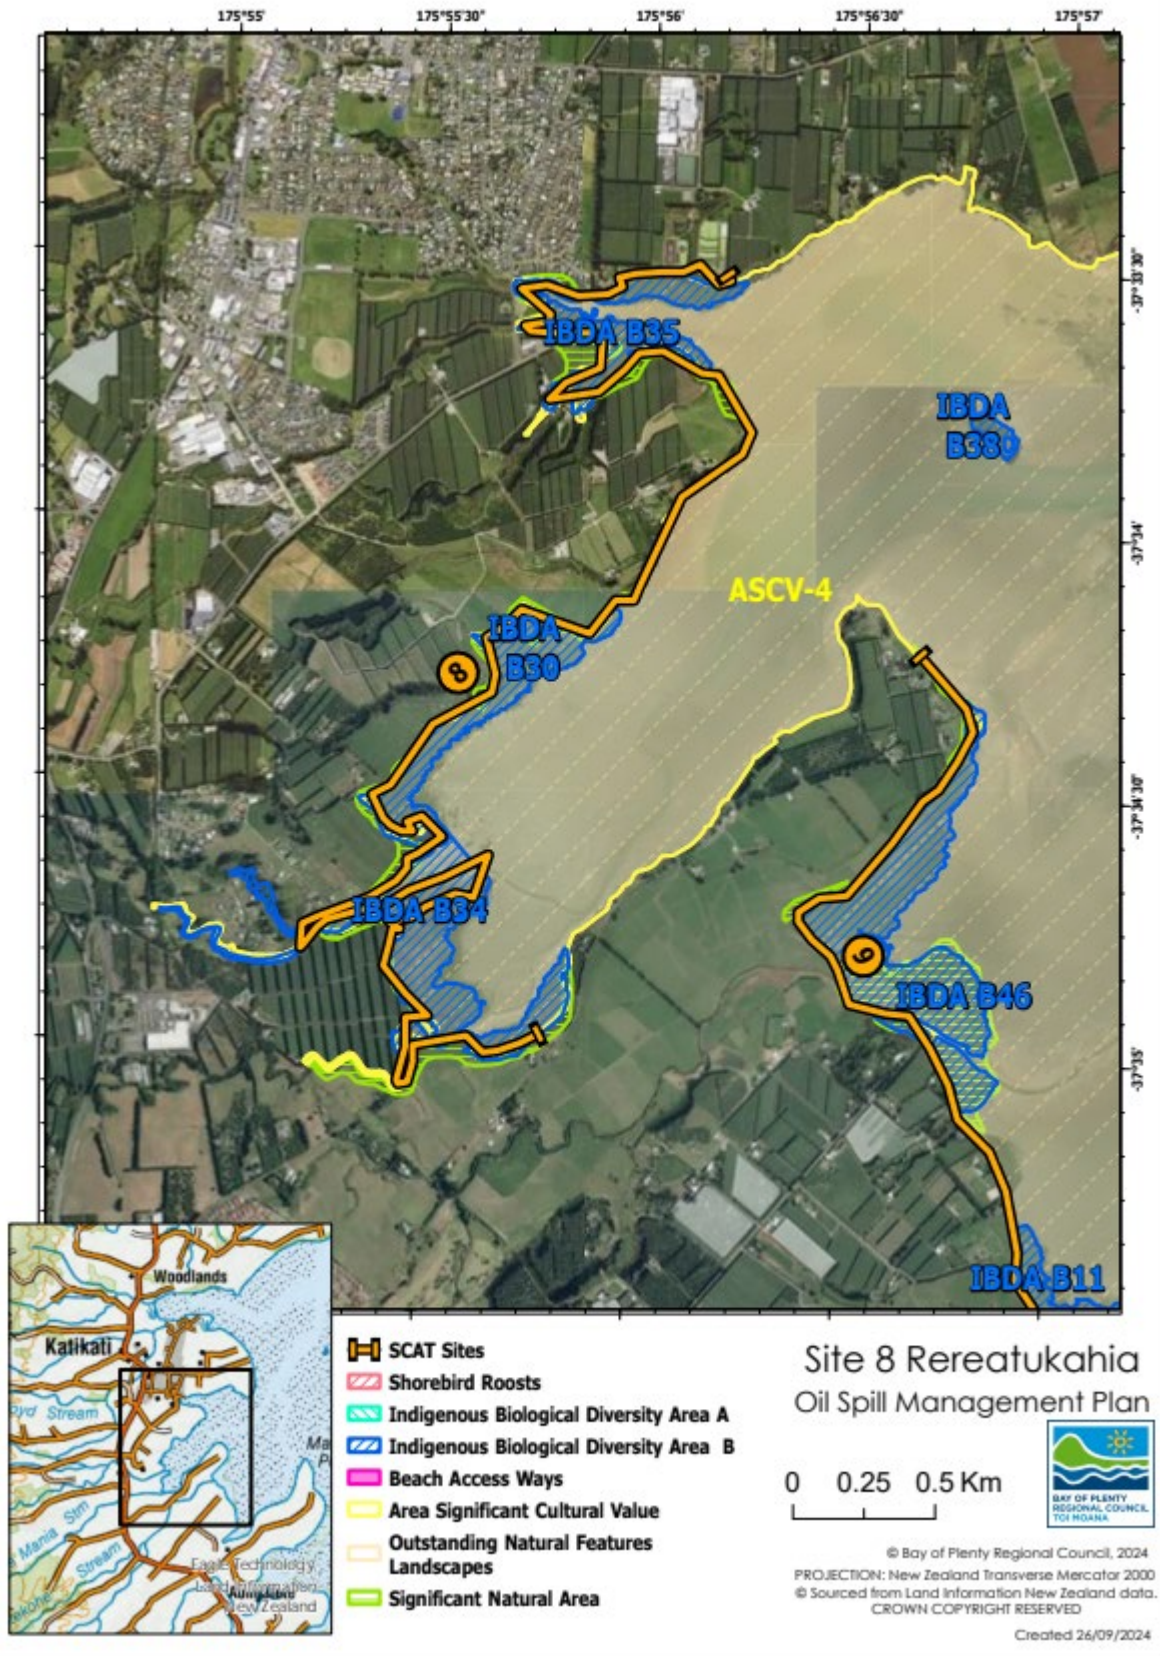
| <b>DESCRIPTION</b><br>Saltmarsh with mangrove edge, Manuka behind. Rereatukahia Stream flows through middle of site. Intertidal mudflats exposed below mid-tide. Popular whitebaiting stream. | | |
| <b>Foreshore type/environmental value</b> | Intertidal sandflats, saltmarsh, mangroves. All shore segments have habitat value<br><br>All intertidal areas in Tauranga Harbour are identified as Areas of Significant Cultural Value (ASCV 4)<br><br>Indigenous Biological Diversity Area B35, B30, B34 | |
| <b>Access</b><br>Foot via Marae, Rereatukahia Road, Sharp Road | | |
